Manhole Inspection Summary

Manhole # S53C__006MH

Insp Date: **6/20/08 8:15 AM**

Location Address: **2 n highland ave**

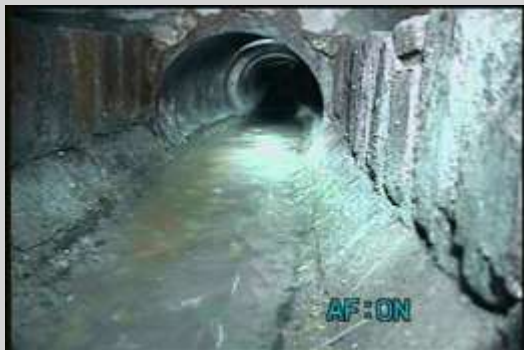
12 O'Clock Outflow

8 in. Circular Gravity Sewer
Pipe Out @ 12 O'Clock

Infiltration: **None** Pipe Seal Cond: **Unknown**
